TEMPORARY IMMERSION AND DUST TEST REPORT

Company : <u>Gold Apollo Co., Ltd</u>

Sample Name : <u>AL-A29</u>

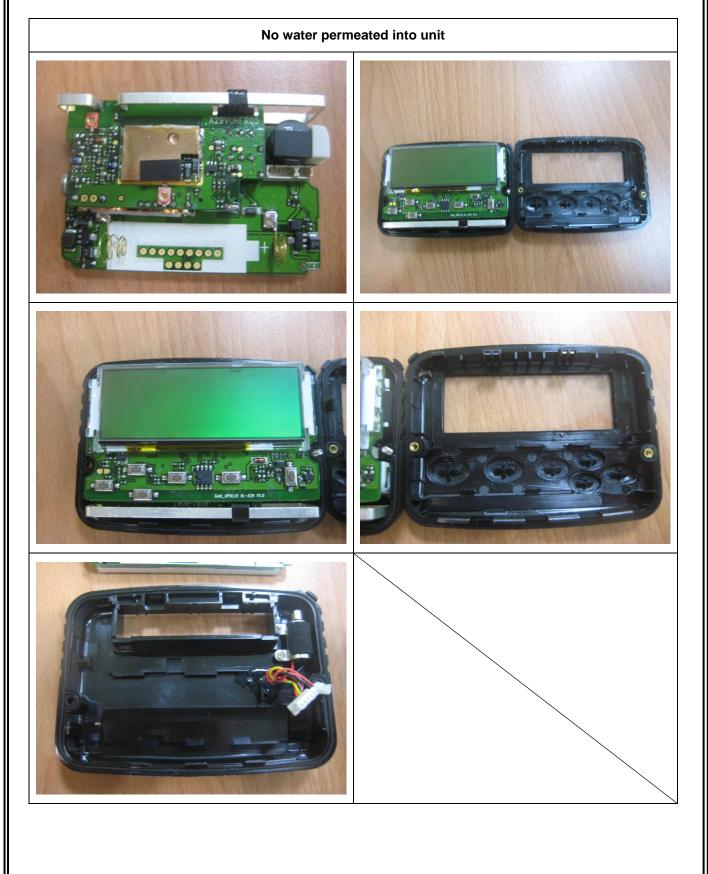
Attachment 3 : Photo of unit after temporary immersion test

After testing, visual inspection showed no water permeated into unit (the inner unit was dry) and no functions check requested from customer. (Please see Attachment 3 on page 7)

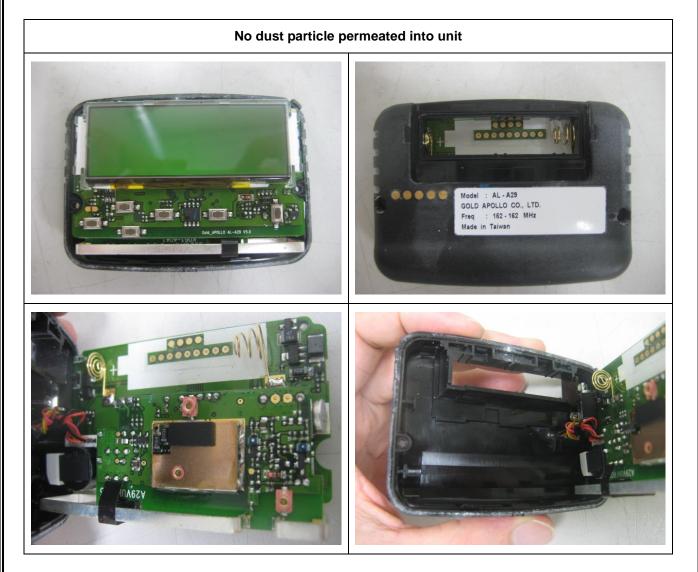
Attachment 4 : Photo of unit after dust test

After testing, visual inspection showed no dust particle permeated into unit and no functions check requested from customer. (Please see Attachment 4 on page 8)
