RAIN AND DUST TEST REPORT

Company : Gold Apollo Co., Ltd

Sample Name : VP101

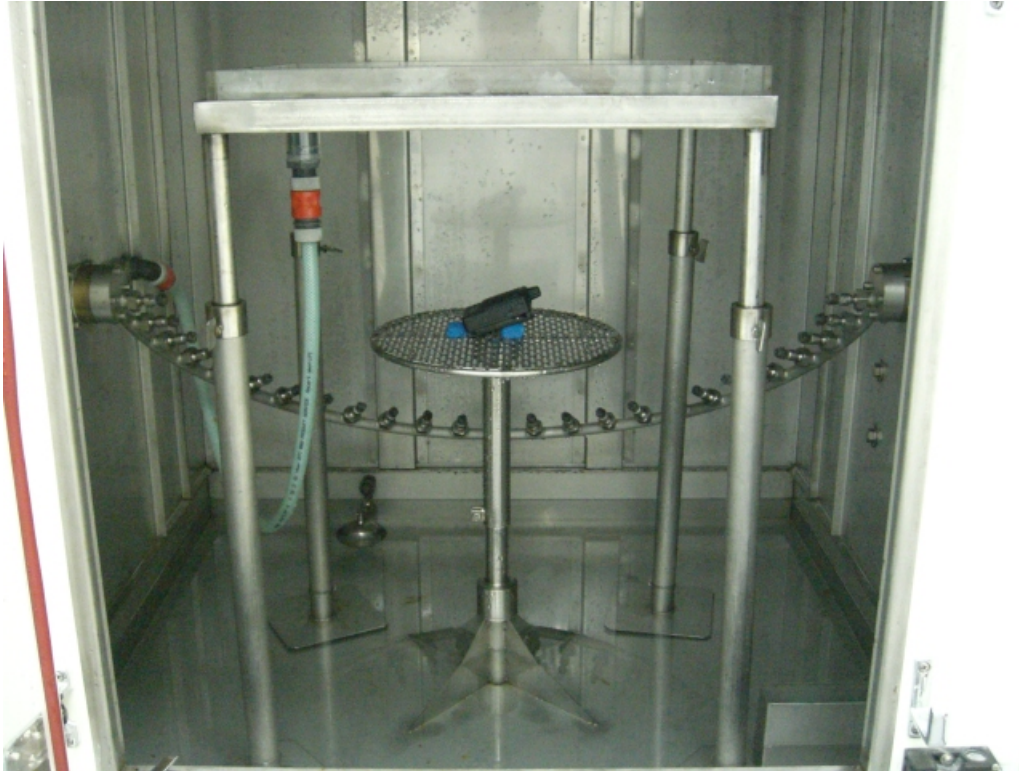
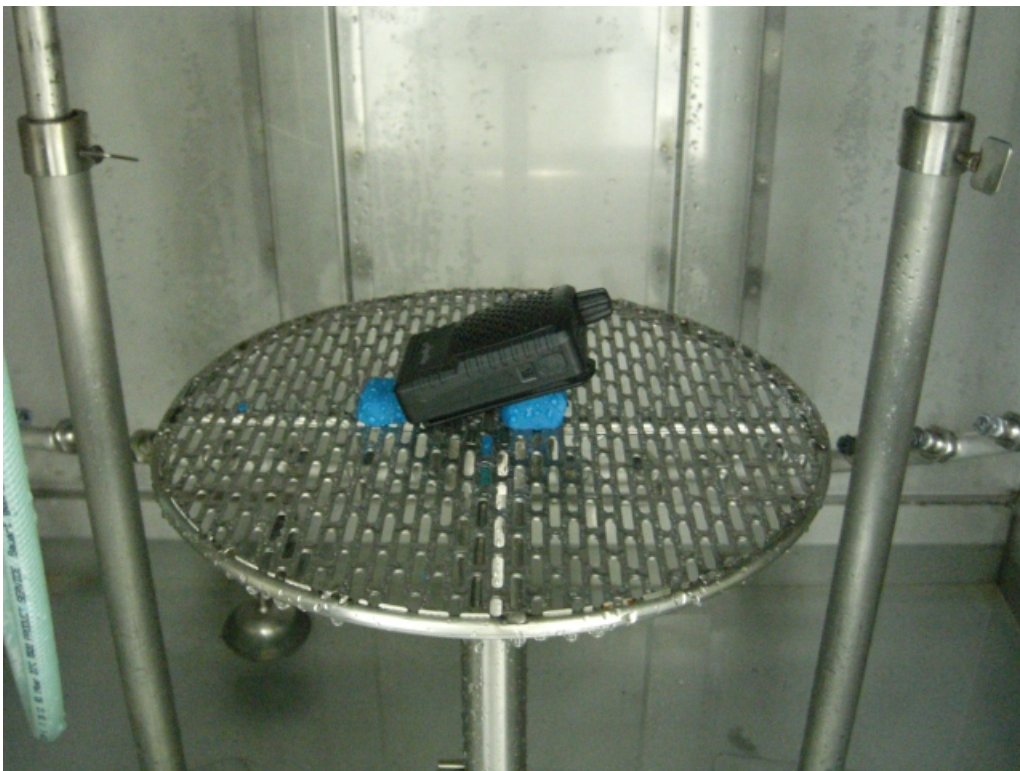
Attachment 1: Photo of rain test

After testing, visual inspection showed no water permeated into the units and units' vibration, lights and sounds were normal.

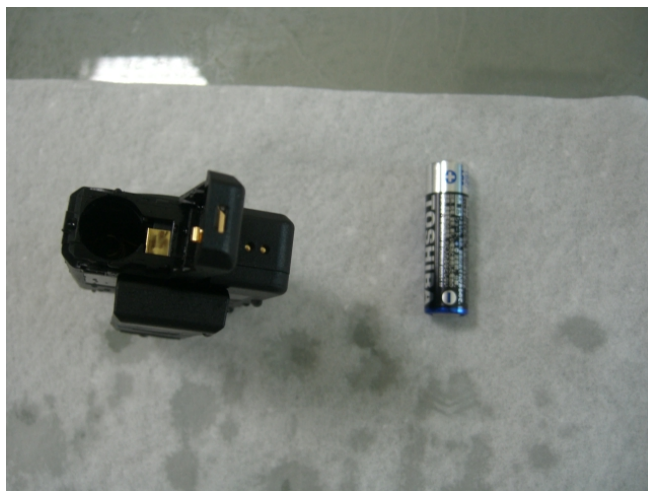
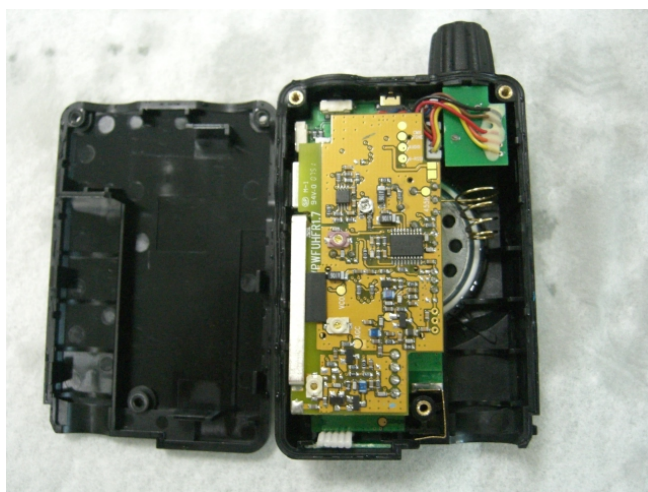
Attachment 2: Photo of unit after rain test

No water permeated into units

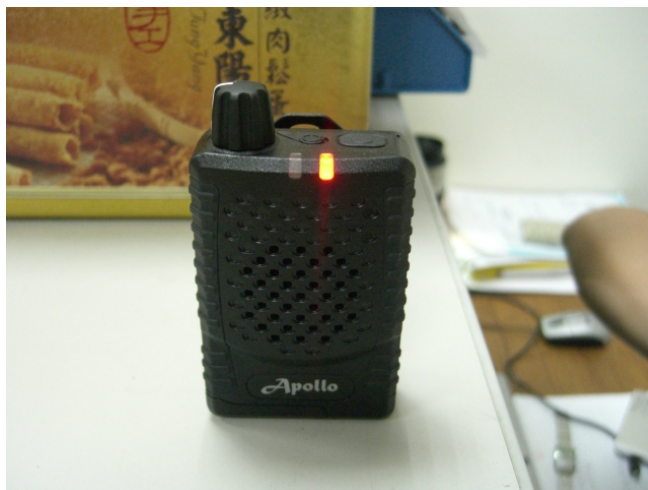
Functions were normal

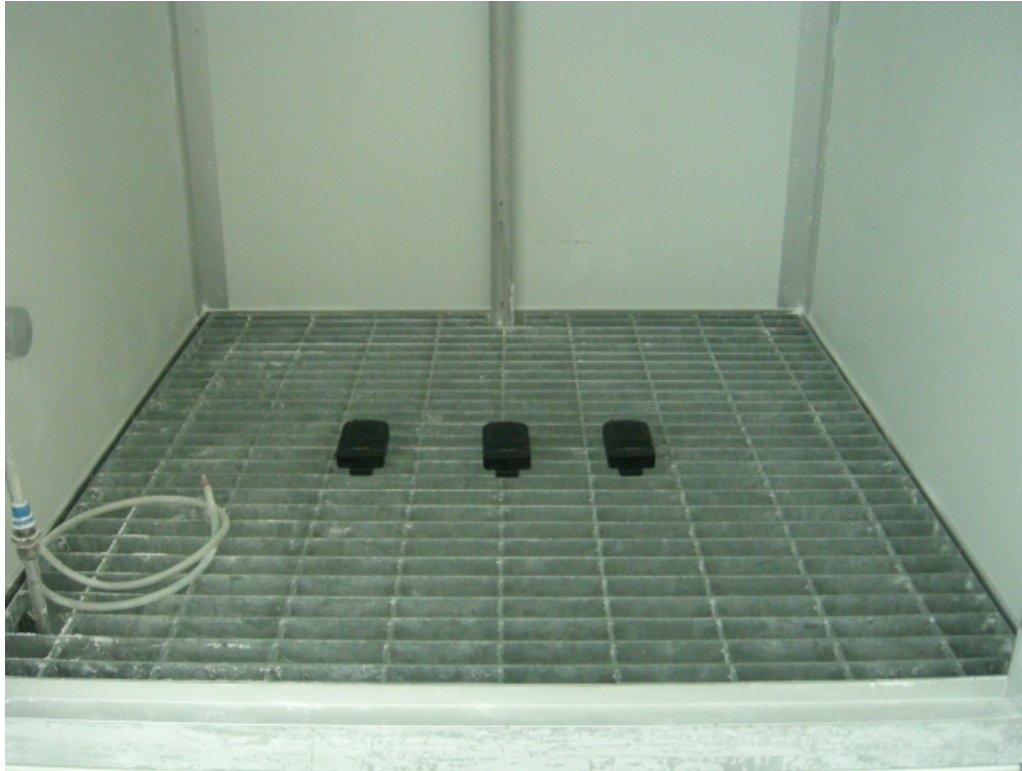
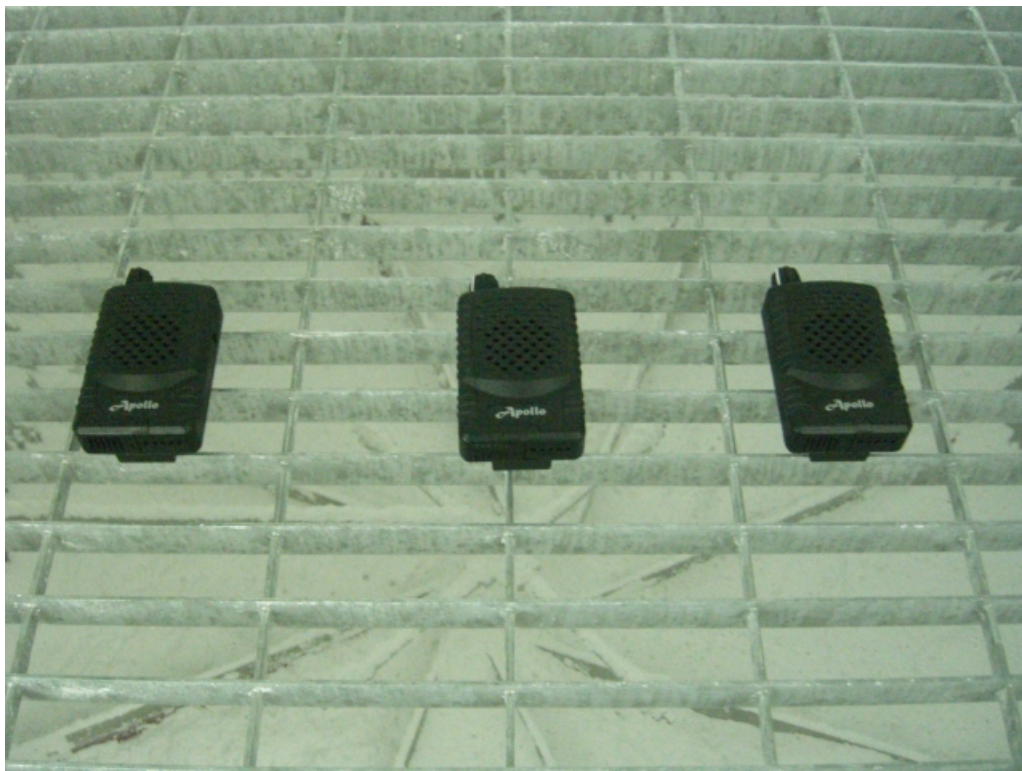
Attachment 3: Photo of dust test

After testing, visual inspection showed no particles permeated into the unit and units' vibration, lights and sounds were normal.

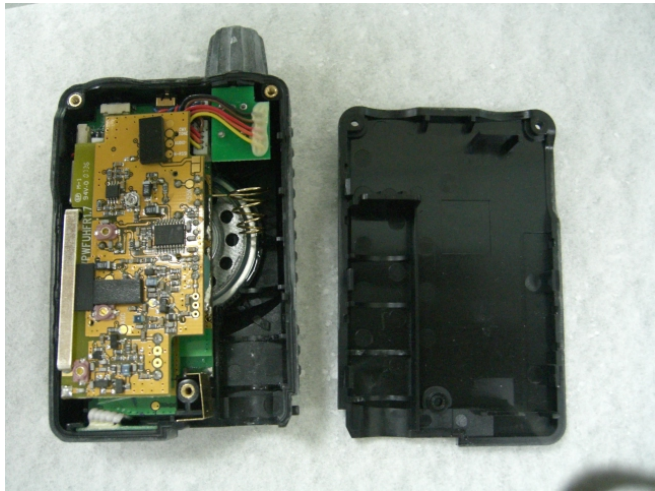
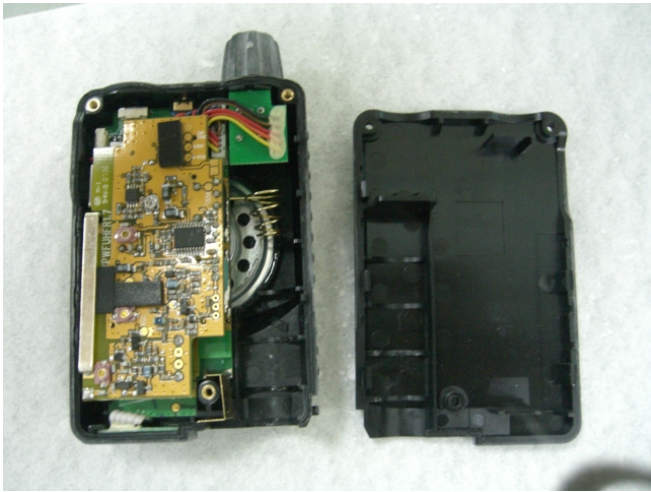
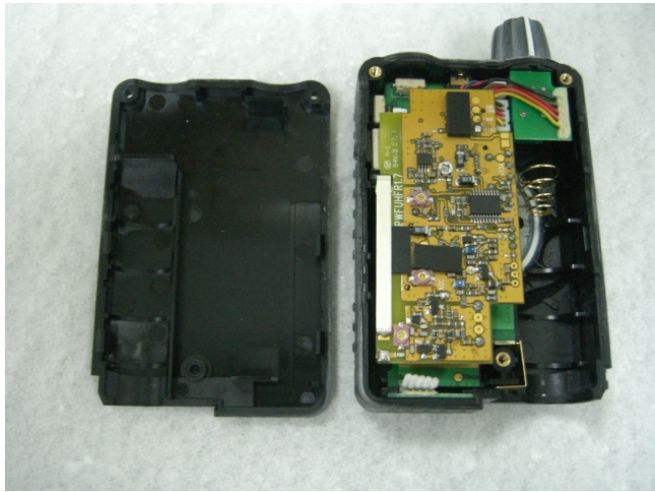
After testing-3	No dust permeated into units-1

No dust permeated into units-2	No dust permeated into units-3

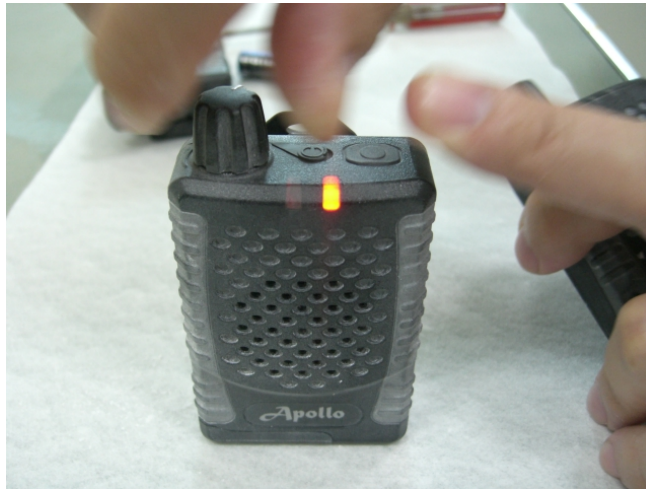
Functions were normal
