DUST TEST REPORT

Model Name : <u>A27</u>

RAIN TEST REPORT

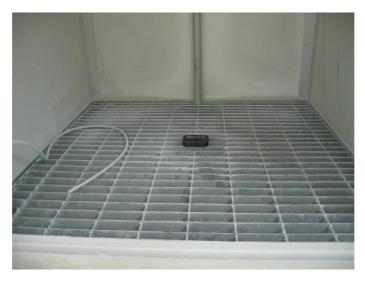
Attachment 1 : Photo for dust test setup

Air direction : Vertically to achieve slowest possible downward settlement

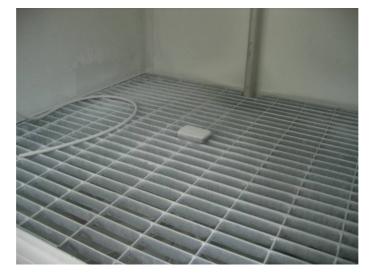
Attachment 2 : Photo for after dust test

After test, no dust permeated into the unit by visual inspection and no functional degradation was noticed.

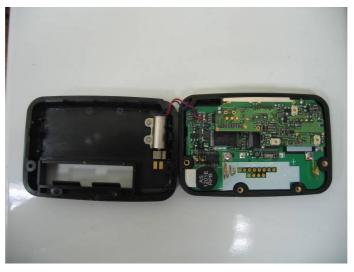
Attachment 3 : Photo for unit after dust test

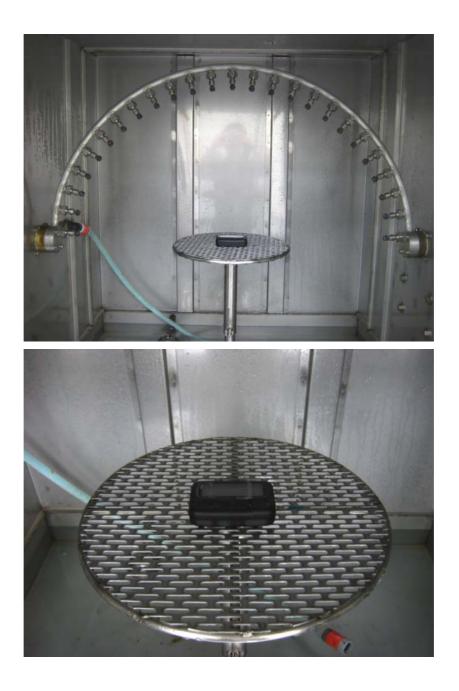
Attachment 1 : Photo of rain test setup

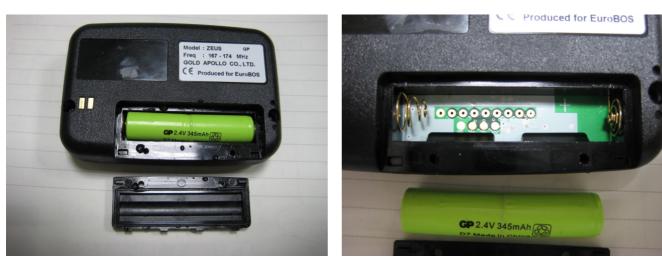
Attachment 2 : Photo of unit after rain test

After testing, the unit inner was dry (no water permeate). No functions check requested from client
