## DUST & WATER PROTECTION TEST REPORT

Job description : IP56 dust and water protected test.

Sample name : AL-A28

## RAIN TEST REPORT

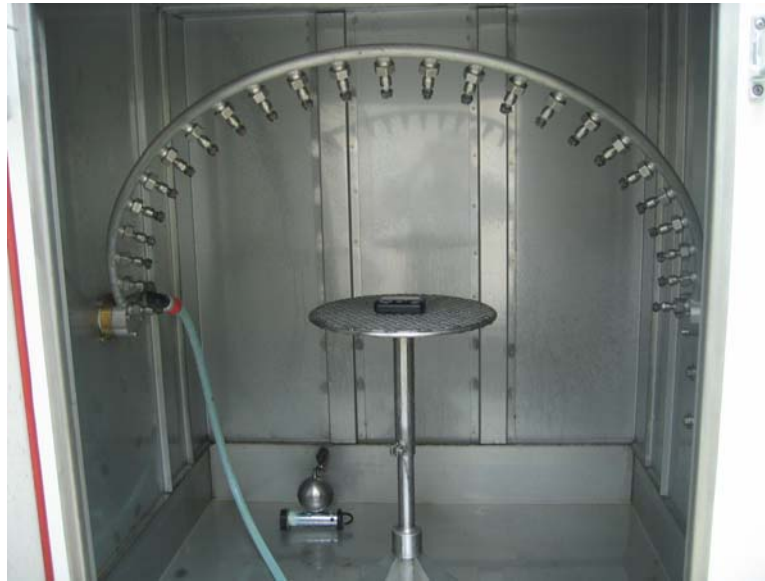
**Attachment 1 : Photo for rain test setup**

Radius of oscillating tube : 400 mm

Diameter of nozzle : 0.4 mm

Number of open holes : 25

Water flow rate : 0.07 l/minute per hole (Total : 1.8 l/minute)

Test duration : Totally test duration is 10 minutes. after 5 minutes spray test, the turned of the unit through a horizontal angle of  $90^{\circ}$  and test is continued for a further 5 minutes.

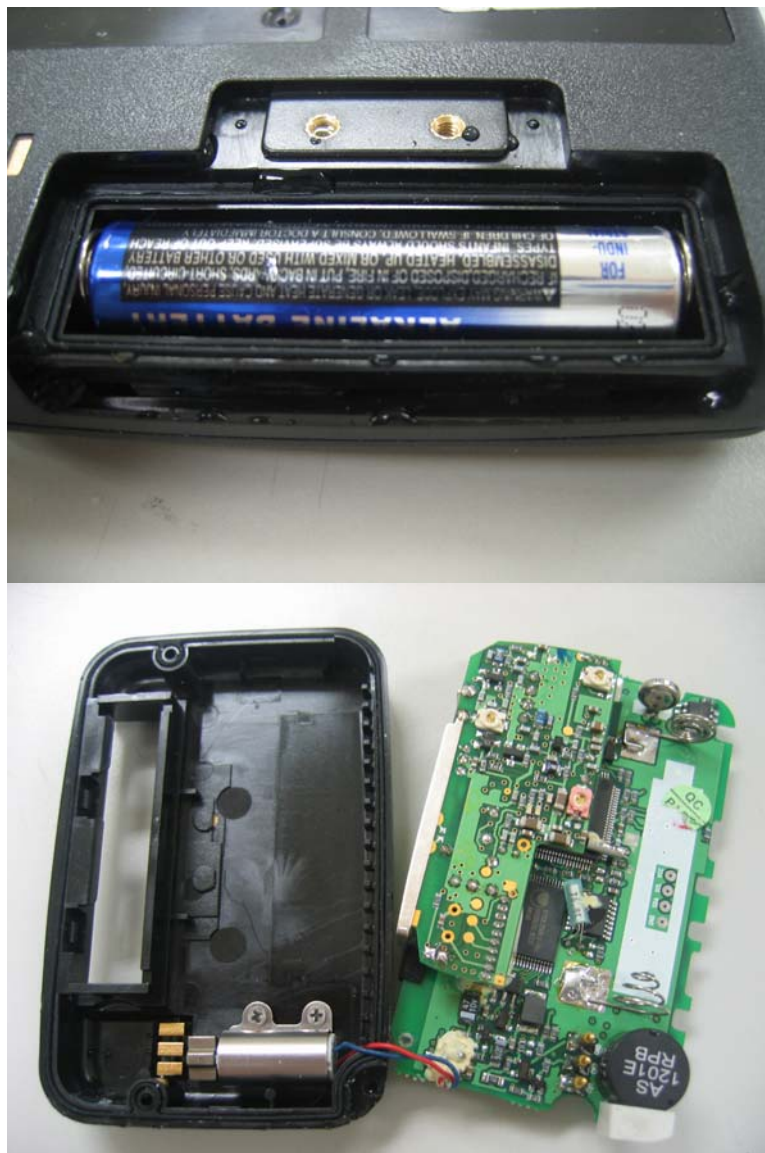
**Attachment 2 : Photo for unit after rain test**

After test, there have some water permeate into the battery location by visible check (See attachment 2, page 5). The unit inner was dry (no water permeate) and function working was normal.
